Manhole Inspection Summary

Manhole # S33CC2021MH

Insp Date: **8/15/08 12:36 PM**

Location Address: **5502 SPRINGLAKE WAY**

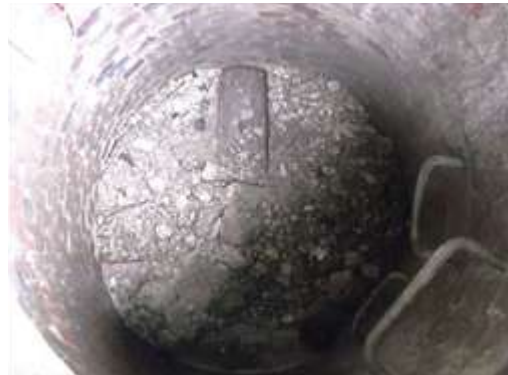
Top View

Bench and Channel debris.

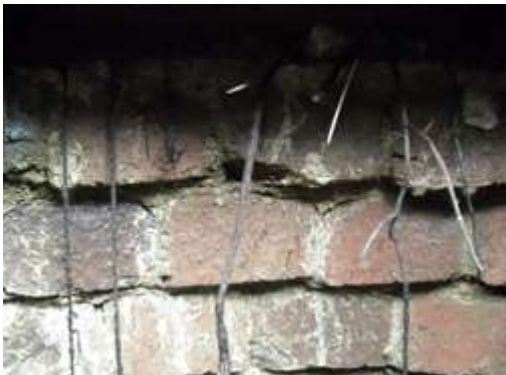
Defect

Corbel root intrusion and infiltration.

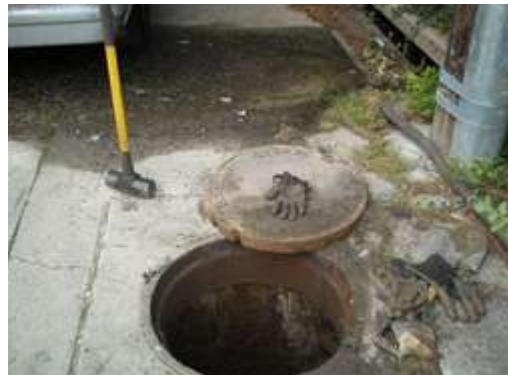
Defect

Frame leaks. Corbel root intrusion and infiltration.

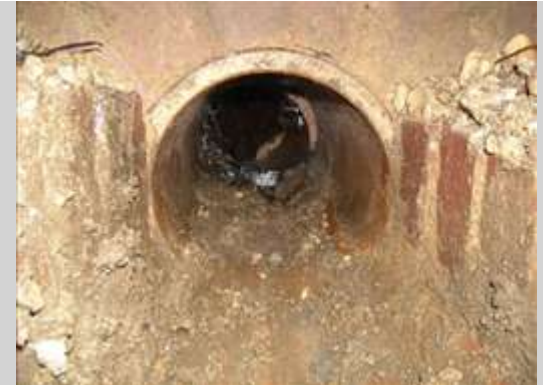
8 in. Circular Gravity Sewer Pipe Out @ 12 O'Clock

Deposits: ☐ None ☒ **Mud** ☐ Sludge ☐ Debris ☐ Grease

Silt Depth: **0.5** (in.) Deposits Extent: **Light**

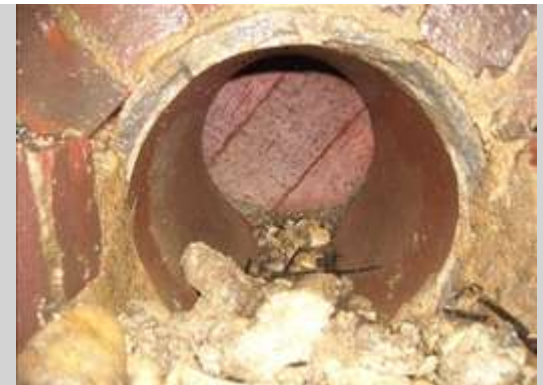
Pipe In @ 9 O'Clock

Connects To: **Stub connection / abandoned**
